<b>Owner:</b>	City of Kelowna	<b>Report No.:</b>	ELBRD-01
<b>Project:</b>	El Dorado Boardwalk Inspection	<b>Reference/Project No.:</b>	2023-2781
<b>Component:</b>	Boardwalk Structure	<b>Date:</b>	June 5, 2025
<b>Location:</b>	Boardwalk adjacent to El Dorado Resort	<b>Issue Copies To:</b>	Geert Bos (CoK) Scott Bushell (CoK)
<b>AE Representative:</b>	Drew Teal, P.Eng.; Sisay Tadele, E.I.T.; Ellen Shinn	<b>Project Manager:</b>	Drew Teal
<b>Others Present:</b>	Morgan Reynolds (Argus)	<b>Owner Contact:</b>	Geert Bos
<b>Time on Site:</b>	11:30 – 2:00	<b>Contractor:</b>	CoK
<b>Weather:</b>	Sunny, 28C	<b>Other:</b>	Argus Properties Ltd.

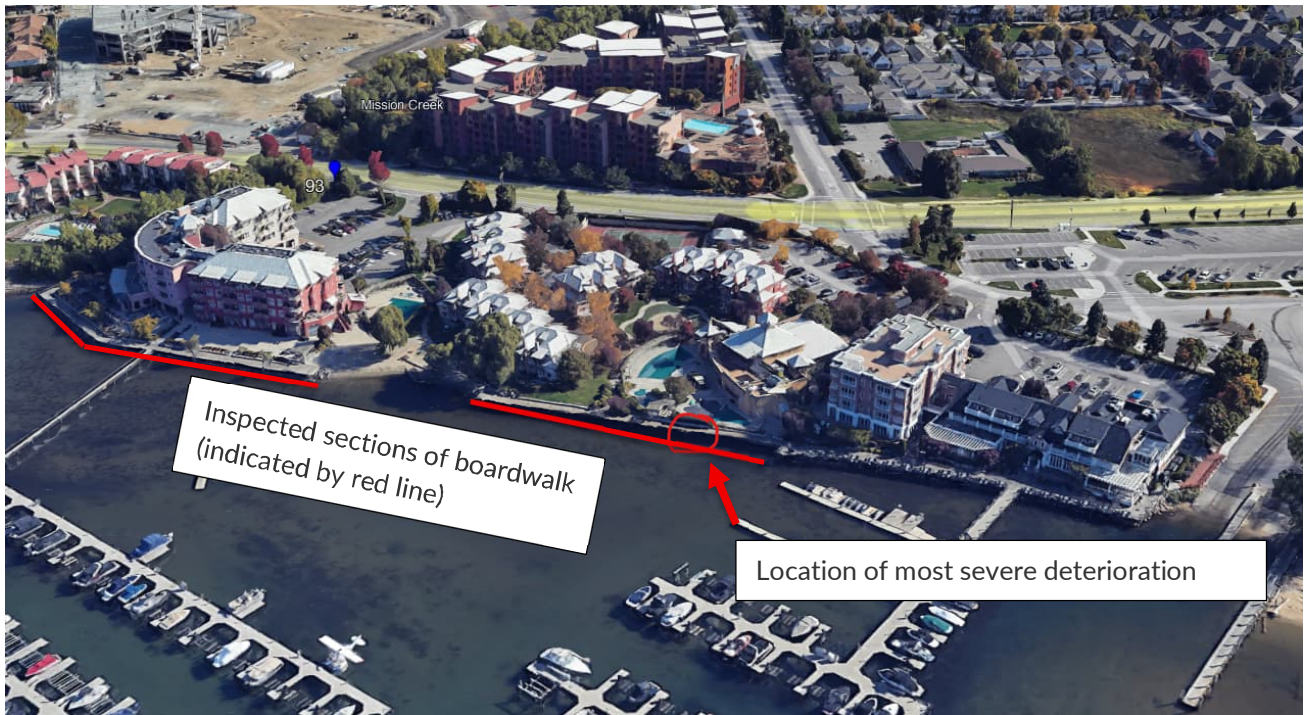
**Figure 2-1** El Dorado Resort boardwalk inspection scope

Sections of the boardwalk had planks that were rotten on the shore side. The planks were designed to cantilever out over the water creating uplift on the shore-side fasteners, which were no longer secured in sound material due to rot. The planks that had experienced rot on the shoreside were no longer adequately fastened down to resist overturning when pedestrian load was on the cantilever section. This resulted in structural instability that could have resulted in sudden failure of the boardwalk under the right loading conditions. For this reason, AE determined that public access to the area needed to be blocked.

Figure 2-1 illustrates the location of the most severe deterioration identified.

Other areas of deterioration were also identified, but these areas had not deteriorated to the same level of severity as the area identified in Figure 2-1.

AE recommended blocking public access to these areas of the boardwalk as well. Given the distribution of the deteriorated areas, it was determined that closing the entire boardwalk was more practical and effective than closing several sections. At approximately 1:45 pm City crews arrived with barricades and public access to the entire boardwalk was blocked.

Areas of deterioration will require repair before the boardwalk can be reopened to the public. Sisay Tadele and Ellen Shinn (AE) will mark planks requiring replacement. The area of severe deterioration (as indicated in Figure 2-1) will require replacement of the timber ledger/nailling strip below the shoreside end of the planks in addition to the planks to be replaced.

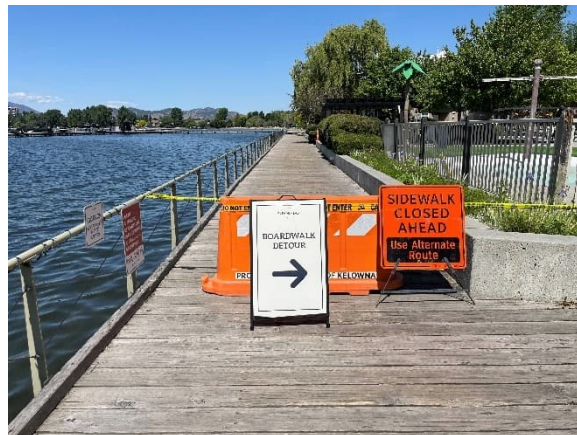
**Figure 2-2** Boardwalk barricades in place

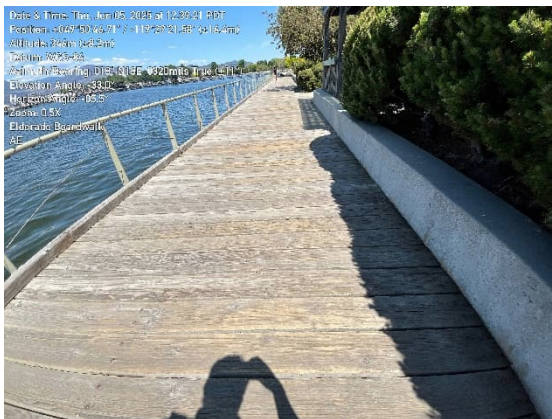
**Figure 4-1 El Dorado boardwalk**

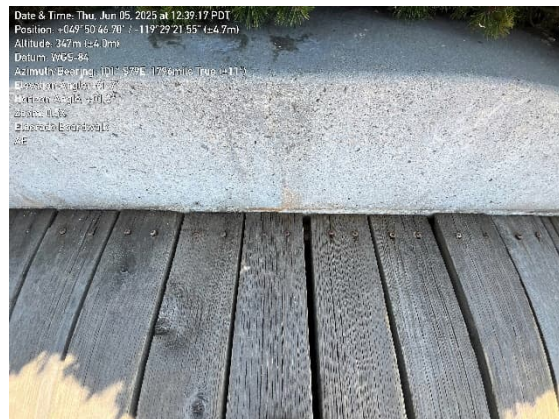
**Figure 4-2 Deteriorated planks**

Repairs should be carried out with like-for-like replacements of the existing materials.

- 102 x 203mm (4x8") full dimension rough cut D. Fir-L #2 or better planks
- Stain timber planks with CETOL 1, colour 'natural 078'
- Fasteners to be 9.5 x 185mm GRK RSS lag screws
