Reference No. 1314930054-006-L-Rev0

**COVER LETTER – RESULTS OF HYDROGEOLOGICAL ASSESSMENT, GEOLOGICAL REVIEW AND
WATER WELL SURVEY, GLENMORE LANDFILL, KELOWNA, BC**

Project No.: 219.05164.00002

***RE: WATER WELL SURVEY AND BEDROCK GEOLOGY REVIEW IN THE VICINITY OF
THE GLENMORE LANDFILL – 2105 GLENMORE ROAD NORTH, KELOWNA, BC***

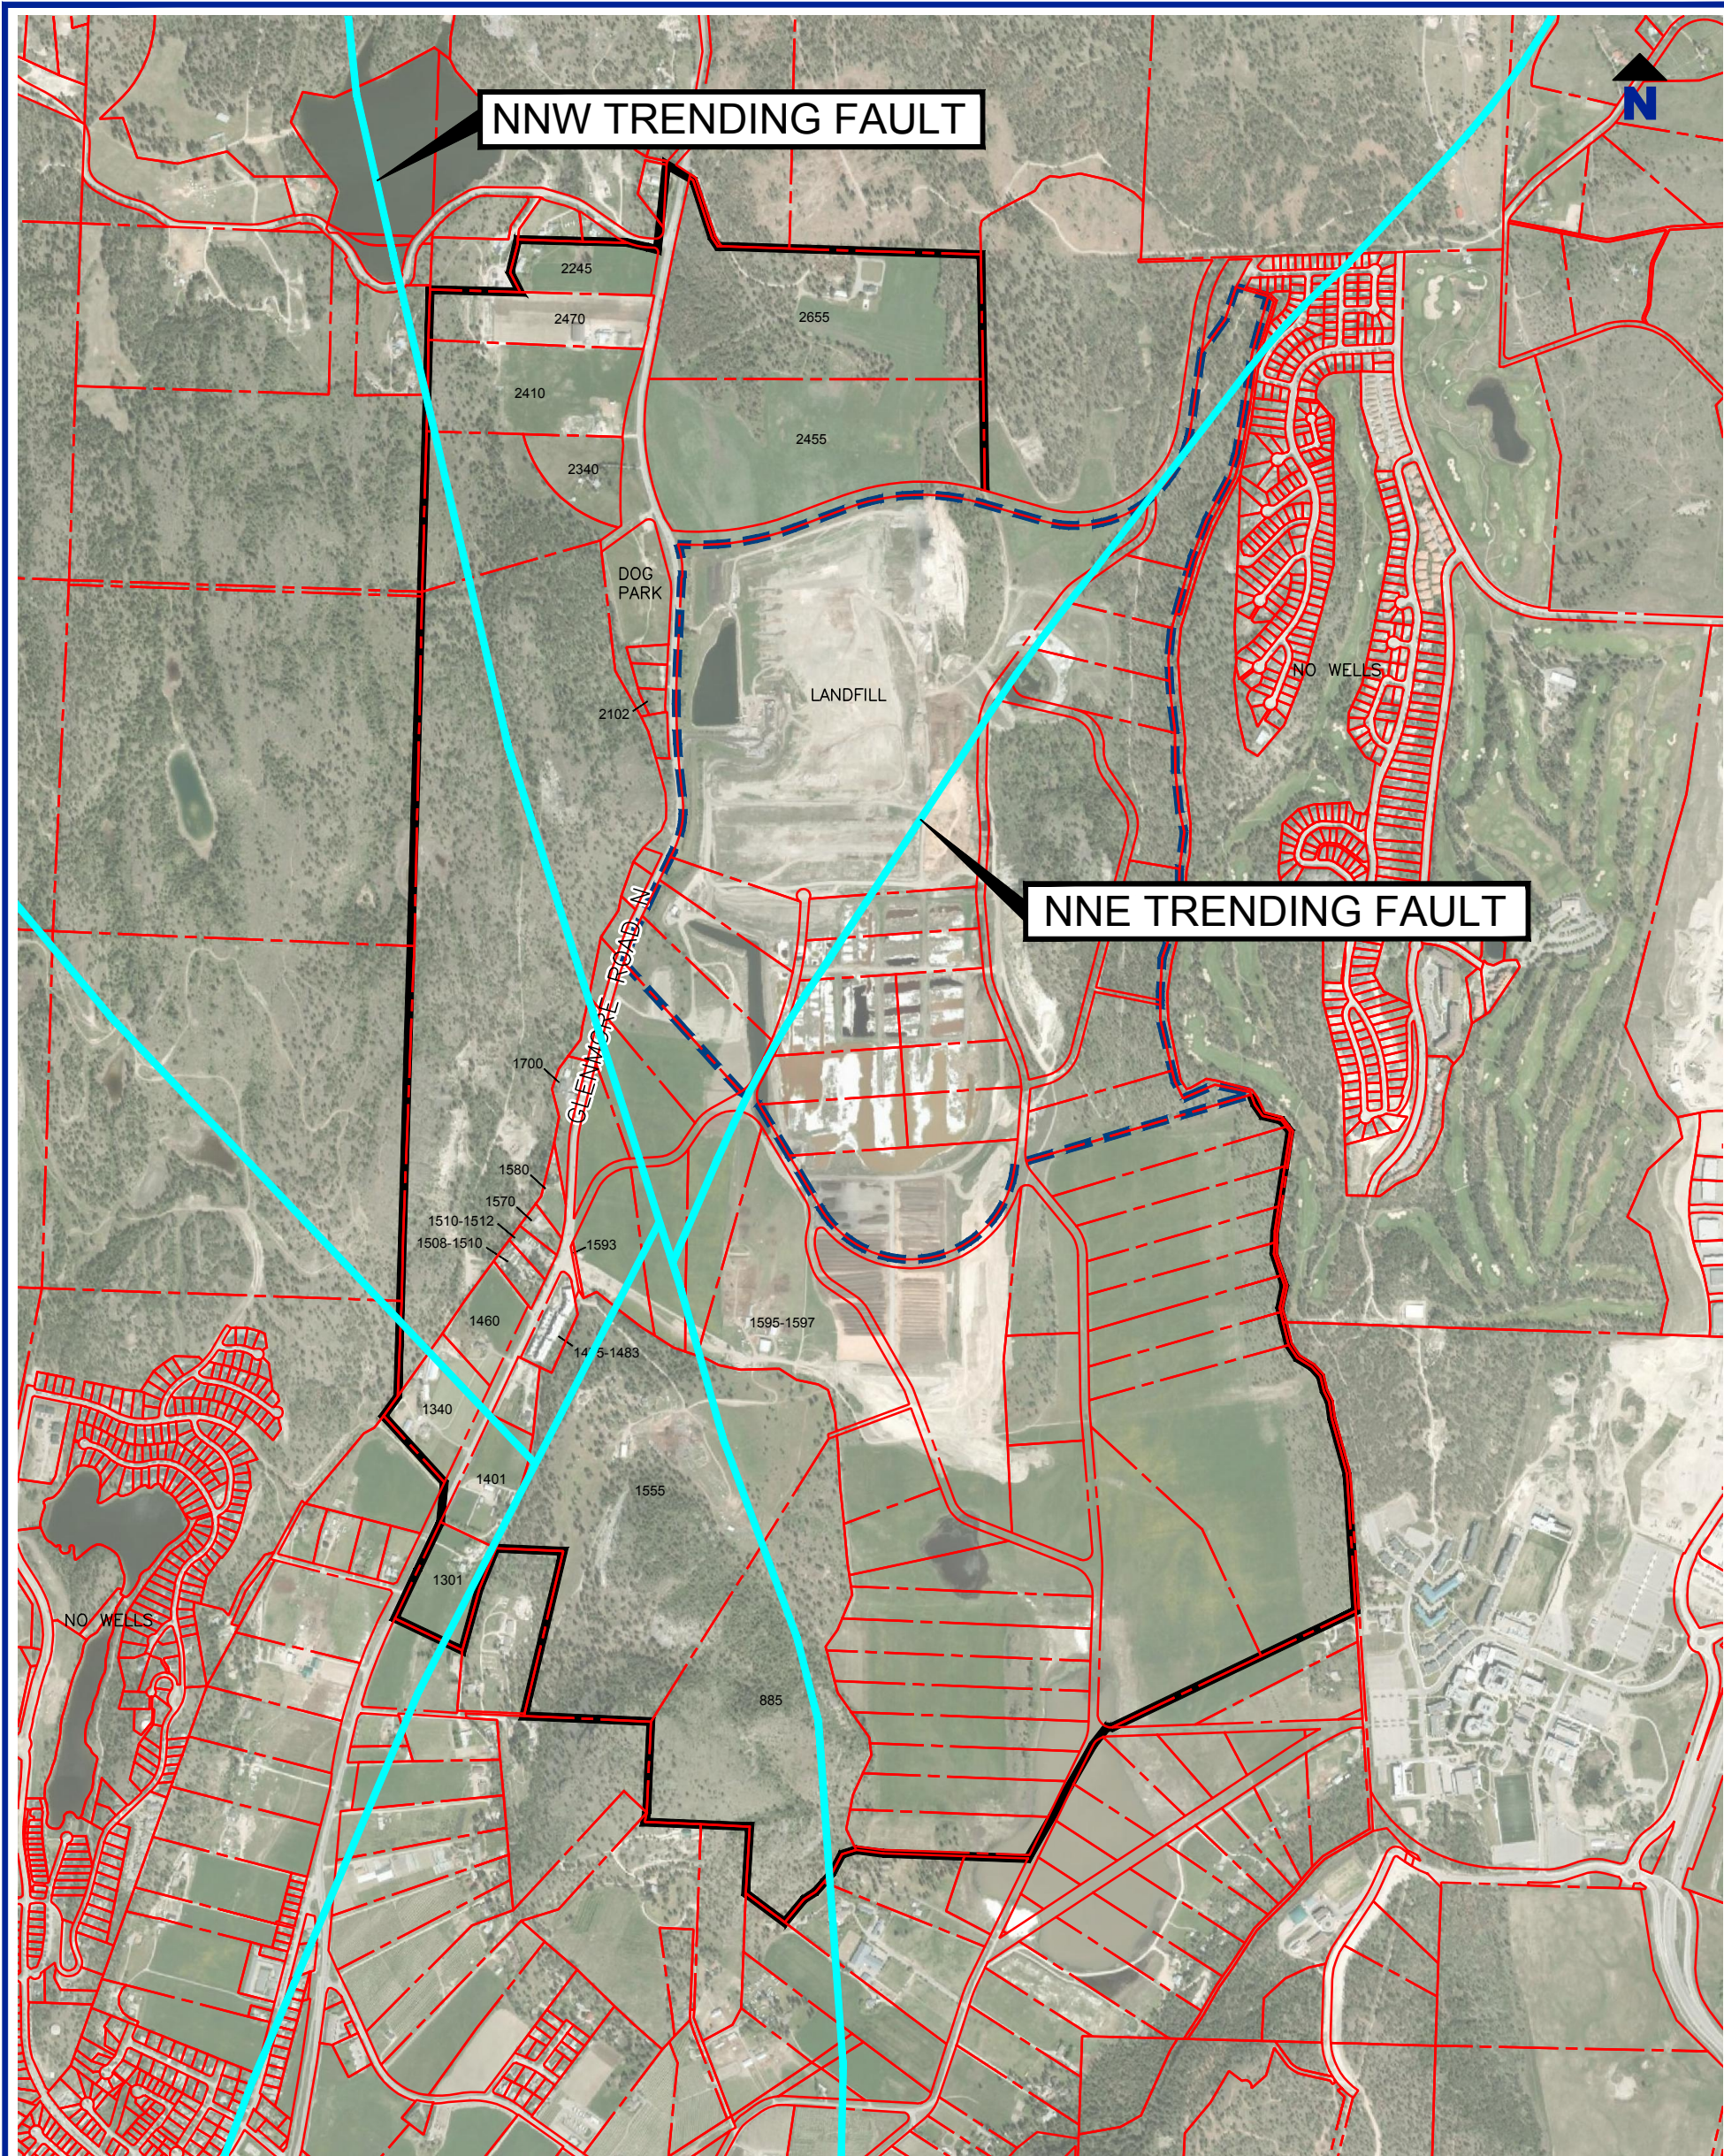
Information on bedrock geology for the Glenmore area was obtained from published geological maps and reports and from personal communication with local Geologists. Two geological maps exist for the area. The BC Geological Survey Preliminary Map 45 (Church, 1981), the Geological Survey of Canada map Open File 6839 (Okulitch, 2013). These and iMap BC (provincial mapping website) identify a series of faults in the vicinity of the landfill (see Drawing 1).

All references note the presence of a NNW trending normal fault¹ to the west of the landfill. Church (1981) and Okulitch (2013) note also the presence of a NNE trending normal fault structure in the vicinity of the Landfill, and potentially underlying Phase 3. The NNE trending fault intersects the NNW trending normal fault to the southwest of the Landfill. Beneath the Landfill both faults are mapped by Church (1981) as “approximate”, suggesting some uncertainty regarding their presence and location.

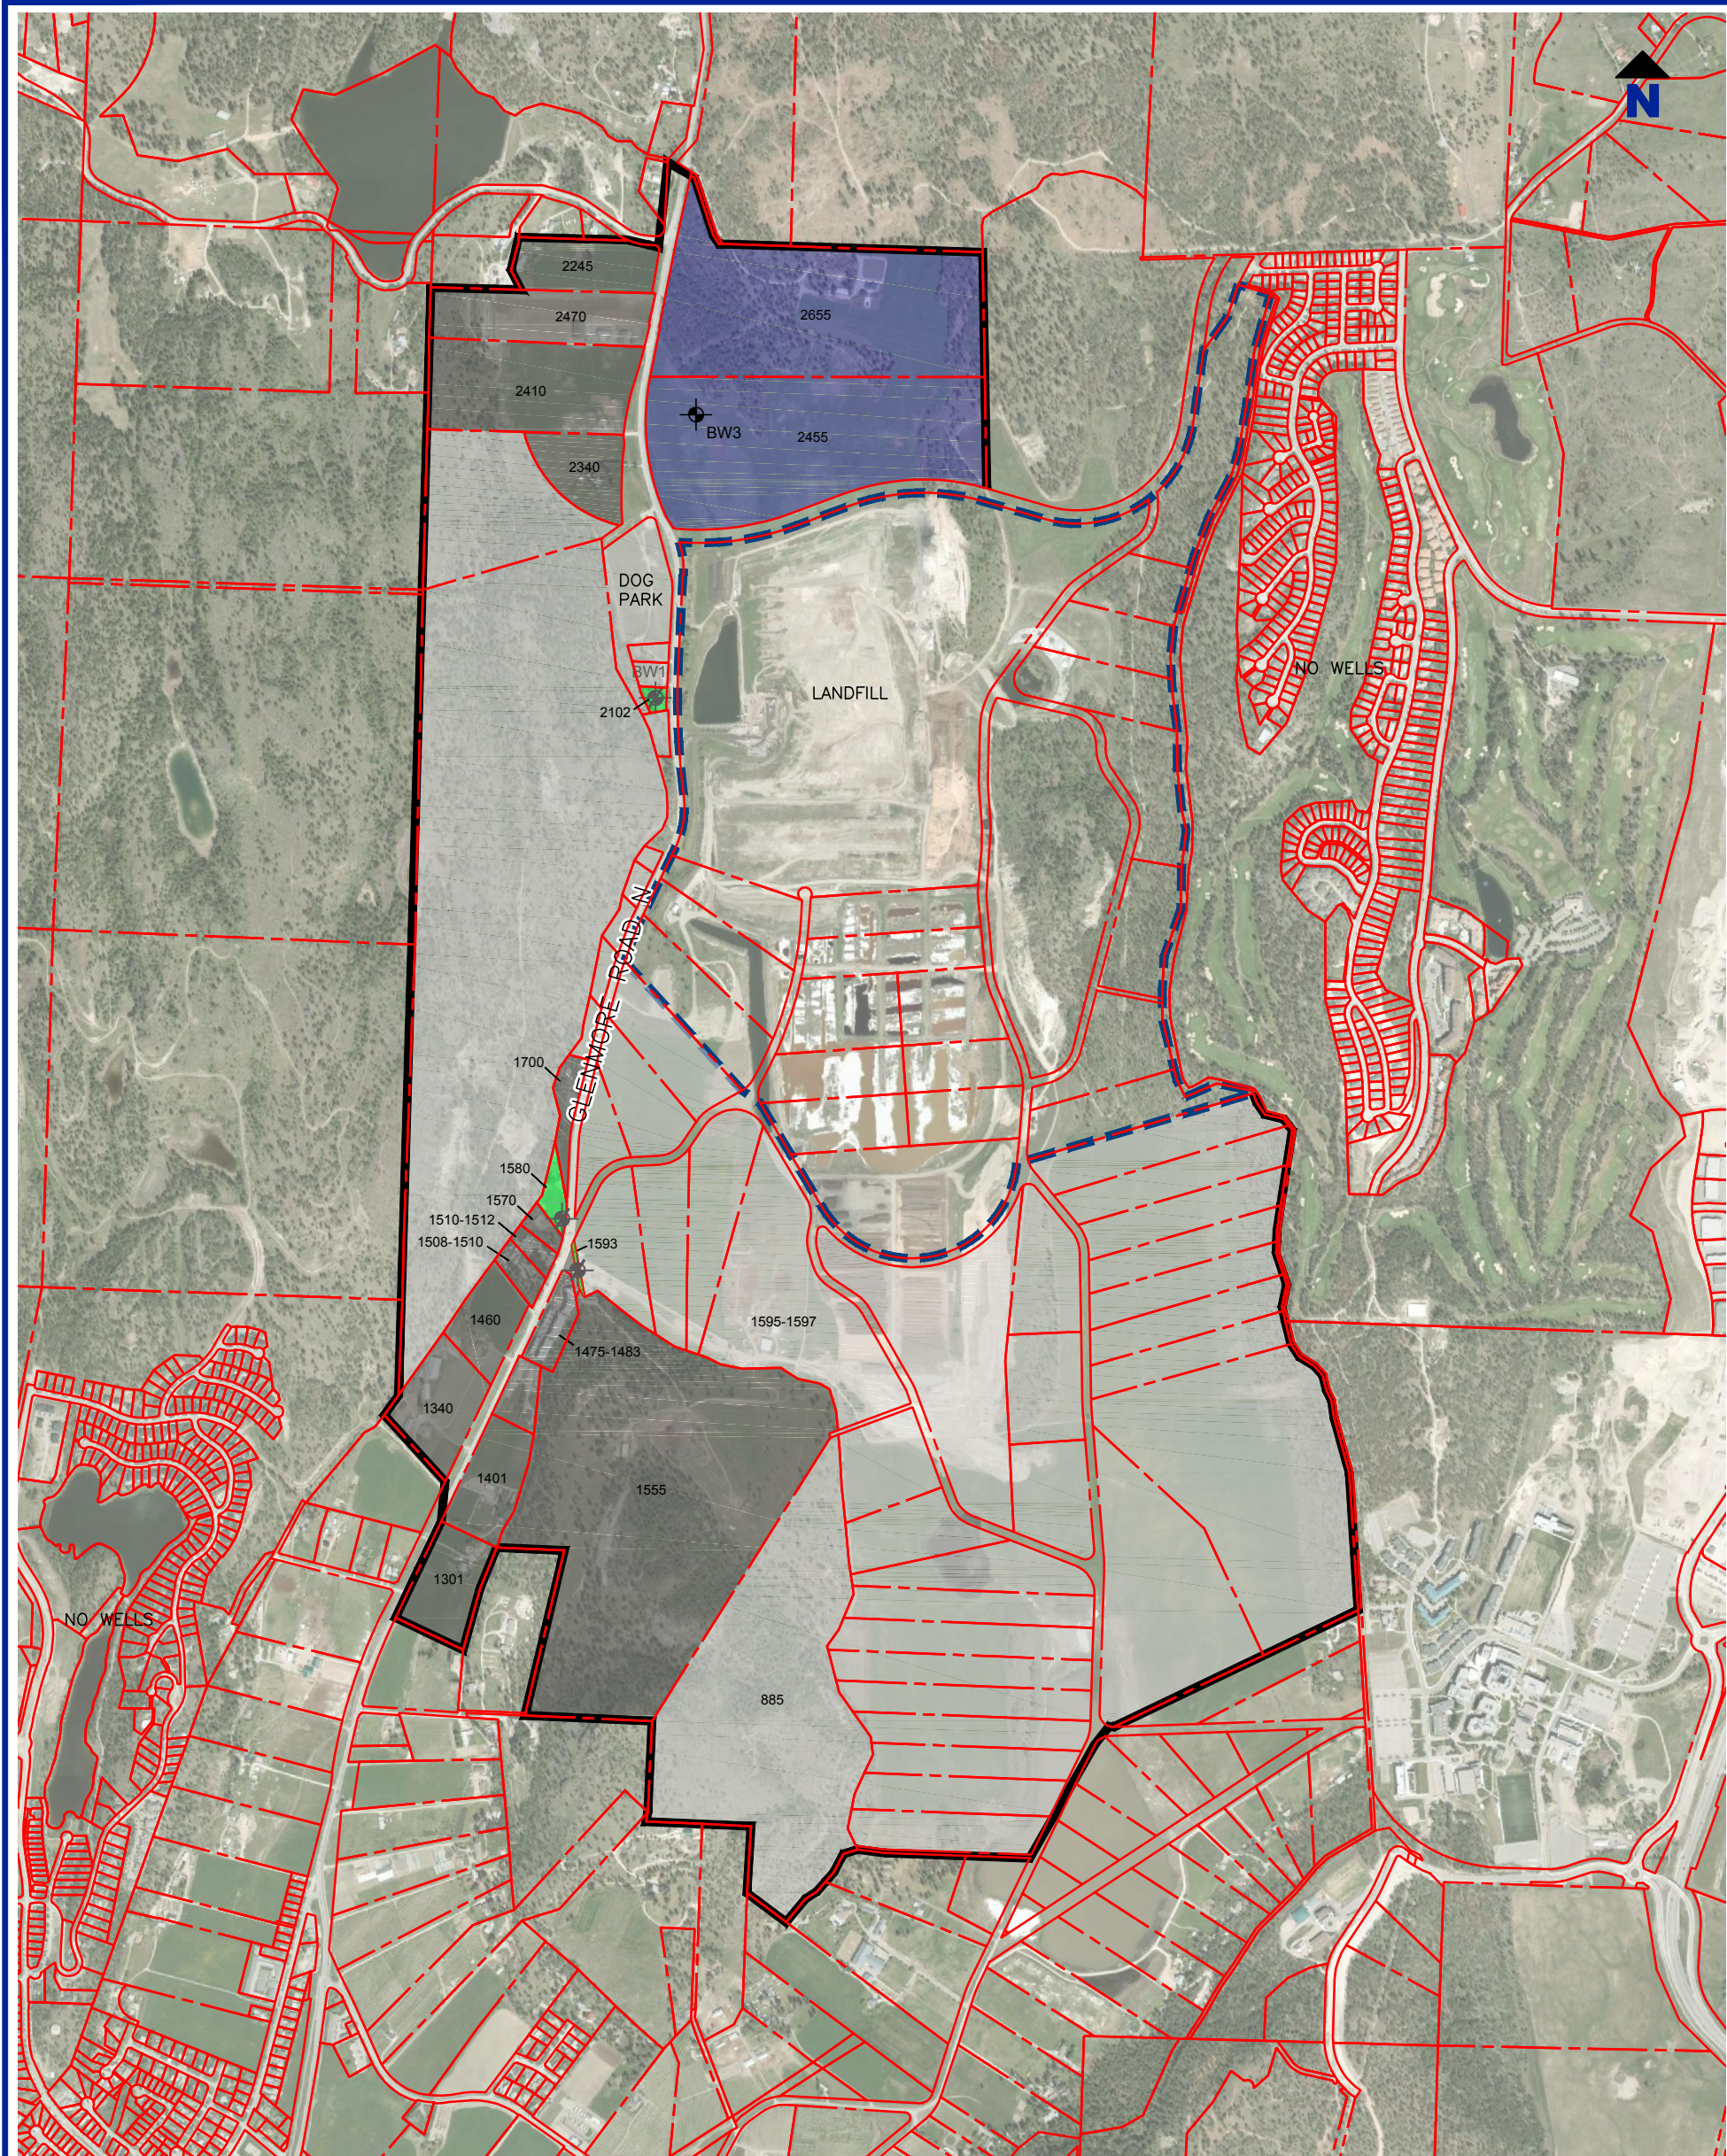
A door to door water well reconnaissance survey was undertaken to determine the location, condition and use of wells located within a 500 m radius of the Glenmore Landfill. A review of the water well registry has shown no wells in this radius, however this registry is not comprehensive and hence the need for the on the ground survey. A 500 m limit was selected north and west of the Landfill, however it was extended slightly south of the landfill to include more properties in this laterally downgradient direction. The 500 m limit to the east is based on the presence of a ridge containing no occupied properties. The water well reconnaissance survey limit shown with respect to the location of the landfill is outlined in red on Drawing 3.

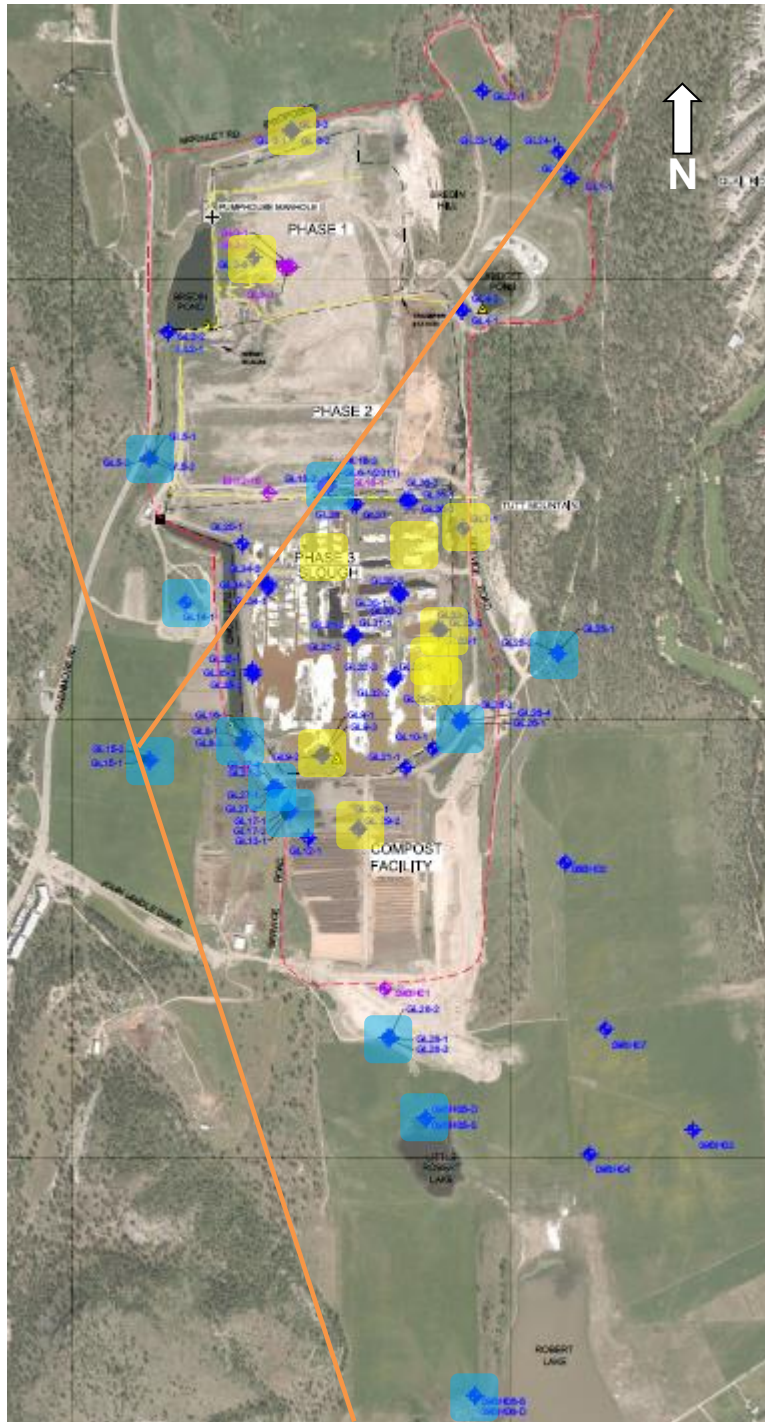
As discussed in the associated SLR report (SLR, 2014), two faults are noted within, and in the vicinity of, the Landfill: a NNW-trending normal fault west of the Landfill and a NNE-trending normal fault that extends across Phase 2 and/or Phase 3 (Okulitch, 2013). The NNE-trending fault intersects the NNW-trending fault southwest of the Landfill. The approximate fault lines are shown in Figure 1 (below).

While it is inferred that the faults exist, based on the review of the borehole logs, it does not appear that a fault(s) or consistent fracture set was encountered during the drilling programs. Where bedrock was encountered during drilling, the borehole was extended up to several metres into the bedrock and a monitoring well installed. In some cases, the monitoring well was installed in the weathered zone above the bedrock, across the upper fractured portion of the bedrock, or across the interface between the bedrock and overlying unit. Few bedrock wells are screened in more-competent bedrock. As discussed in SLR (2014), unconsolidated glaciolacustrine deposits overlie bedrock, with an approximate 3 to 8 m thick clay layer at surface or directly below the MSW unit. Based on the review of the borehole logs and on cross-sections across and along the axis of the basin using information from the borehole logs, there were no apparent unconformities or truncations identified within the unconsolidated glaciolacustrine deposits, suggestive that faulting would have occurred prior to their deposition within, and in the vicinity of, the basin. Given the basin setting, the unconsolidated sediments pinch out (or are non-existent) against the sides of the basin adjacent to the bedrock walls (as observed in the area of GL7-1 along the east side of the basin; and GL14-1 along the west side of the basin), and are thicker in the centre of the basin. It can be inferred from the cross-sections that the sedimentary rocks and the upper

Figure 1. Plan of the Landfill showing areas where sedimentary bedrock (blue shading) and volcanic bedrock (yellow shading) were encountered during various drilling programs conducted between 1990 and 2012. Orange lines represent approximate locations of normal faults identified in Okulitch (2013).

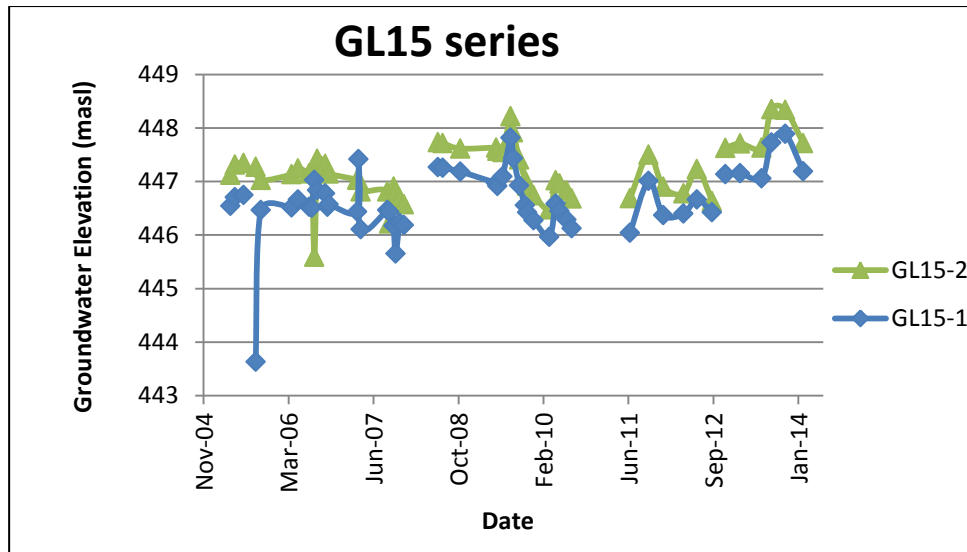
A downward gradient of on average 0.6 m has been observed at well series GL15, between the shallow well (GL15-2) and the deeper well (GL15-1). The ground surface at the GL15 well series is at an elevation of approximately 452 masl. This elevation is roughly 13 m higher than the Slough area located within the Landfill Footprint (Slough is at an elevation of approximately 439 masl). Weathered bedrock (sandstone) was encountered at an elevation of 441.9 masl, followed by more competent bedrock at approximately 439.6 masl. No indication of a fault was identified in the upper portion of the bedrock. As the GL15 well series is located away from the Landfill Footprint and at a higher elevation than the Landfill Footprint, this area is inferred to be a source of recharge for the Slough and Landfill deposits, and thus, localized downward gradients can be expected (see Section 2.2.1 above). Groundwater at the GL15 well series also appears to respond to irrigation of the surrounding fields, where higher groundwater elevations at well GL15-1 are observed during the irrigation period through the summer and fall months (see Figure 2 below). The groundwater elevations in the shallow and deep wells fluctuate in a similar pattern, indicative of a hydraulic connection between the upper and lower units.

Figure 2. Historical groundwater elevations reported at GL15-1 (screened in sandstone containing few fractures) and GL15-2 (screen straddles the sand unit and top portion of underlying glacial till).

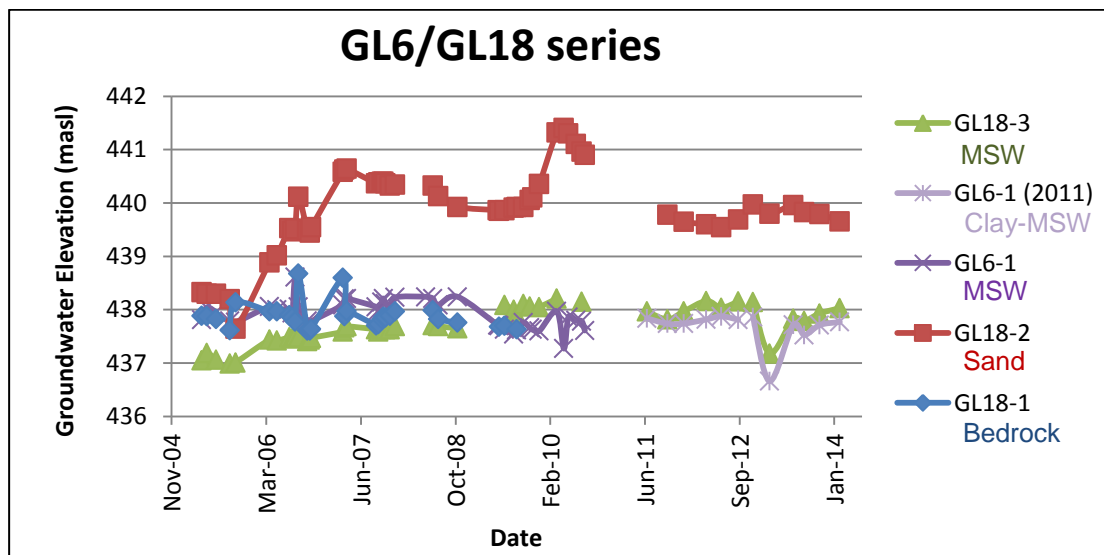
We note that if groundwater in the bedrock was flowing towards the NNE-trending fault, then the groundwater elevation at GL18-1 is expected to have been lower than GL18-3 between 2005 and 2008.

Figure 3. Historical groundwater elevations reported at well series GL6/18. Well GL6-1 (2011) replaced well GL6-1 in 2011. Bedrock well GL18-1 was screened below the weathered zone in siltstone/sandstone containing few fractures.

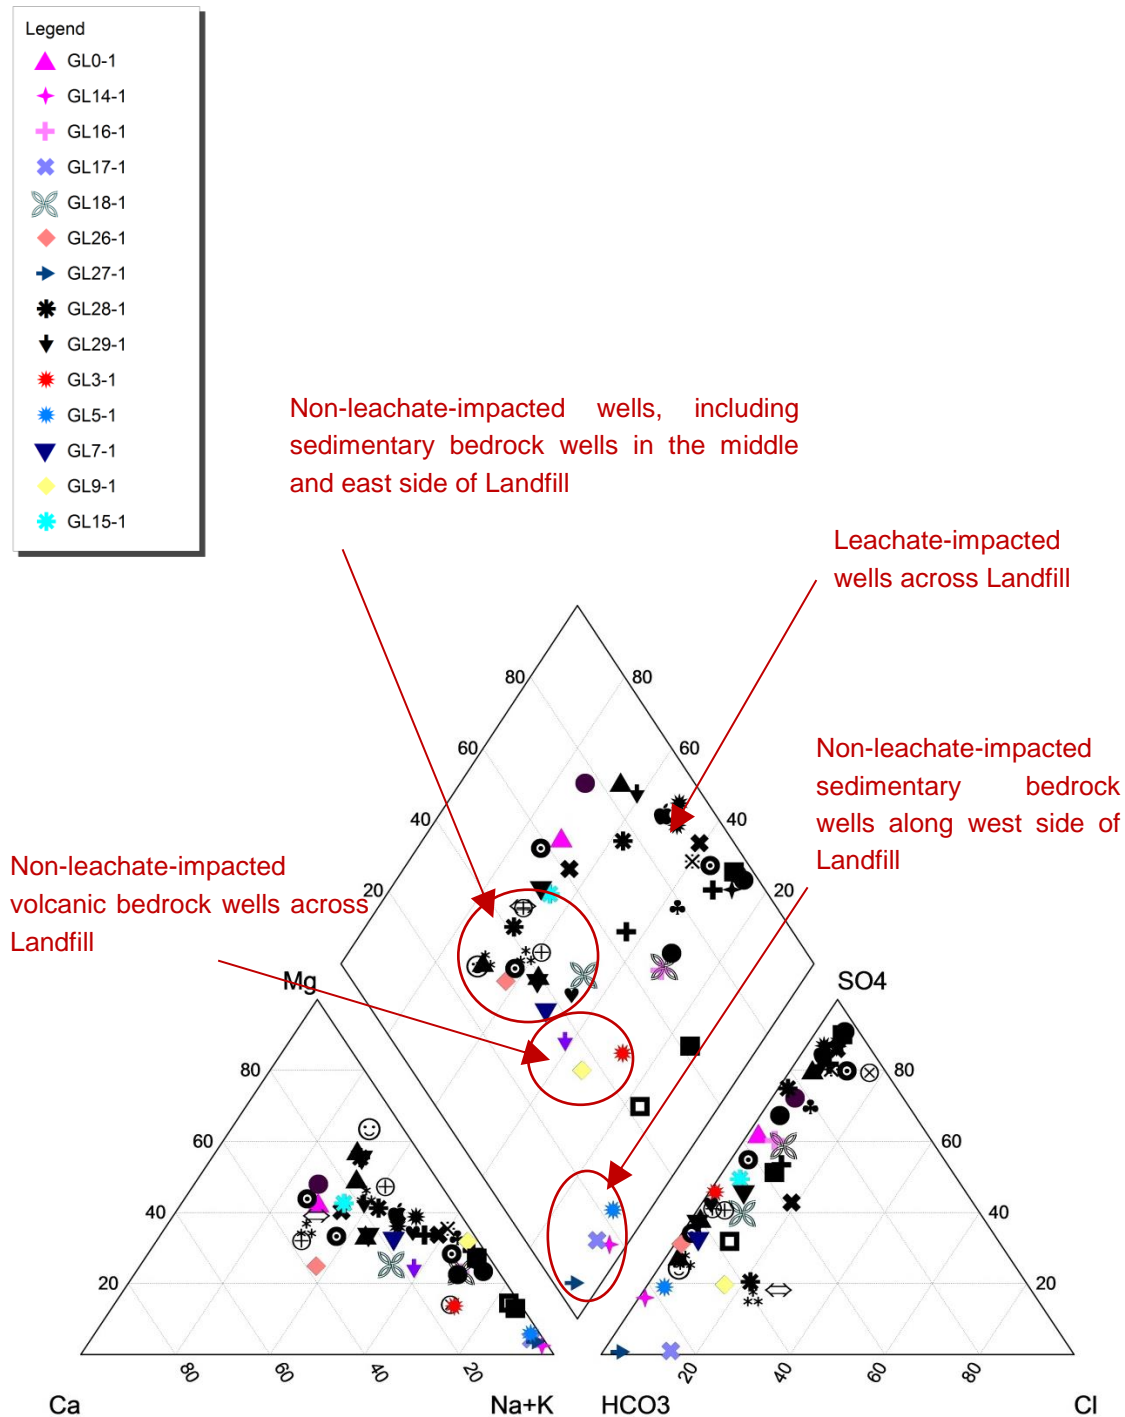
- The groundwater quality at leachate-impacted wells trend toward the upper right portion of the piper plot.
- If groundwater was flowing towards and into the bedrock faults from the glaciolacustrine deposits across the Landfill Footprint, groundwater quality at bedrock wells in the vicinity of the faults would trend towards the upper right portion of the piper plot, in the region of the leachate-impacted wells. Based on the available data, this trend is not observed.

- The most down-gradient bedrock wells at the Landfill (GL9-1, GL17-1 and GL27-1) do not show leachate impacts to groundwater quality.

Figure 4: Piper plot showing most recent (2009 - 2013) available groundwater quality at each well. Bedrock wells are identified in legend and are shown in colour on piper plot.

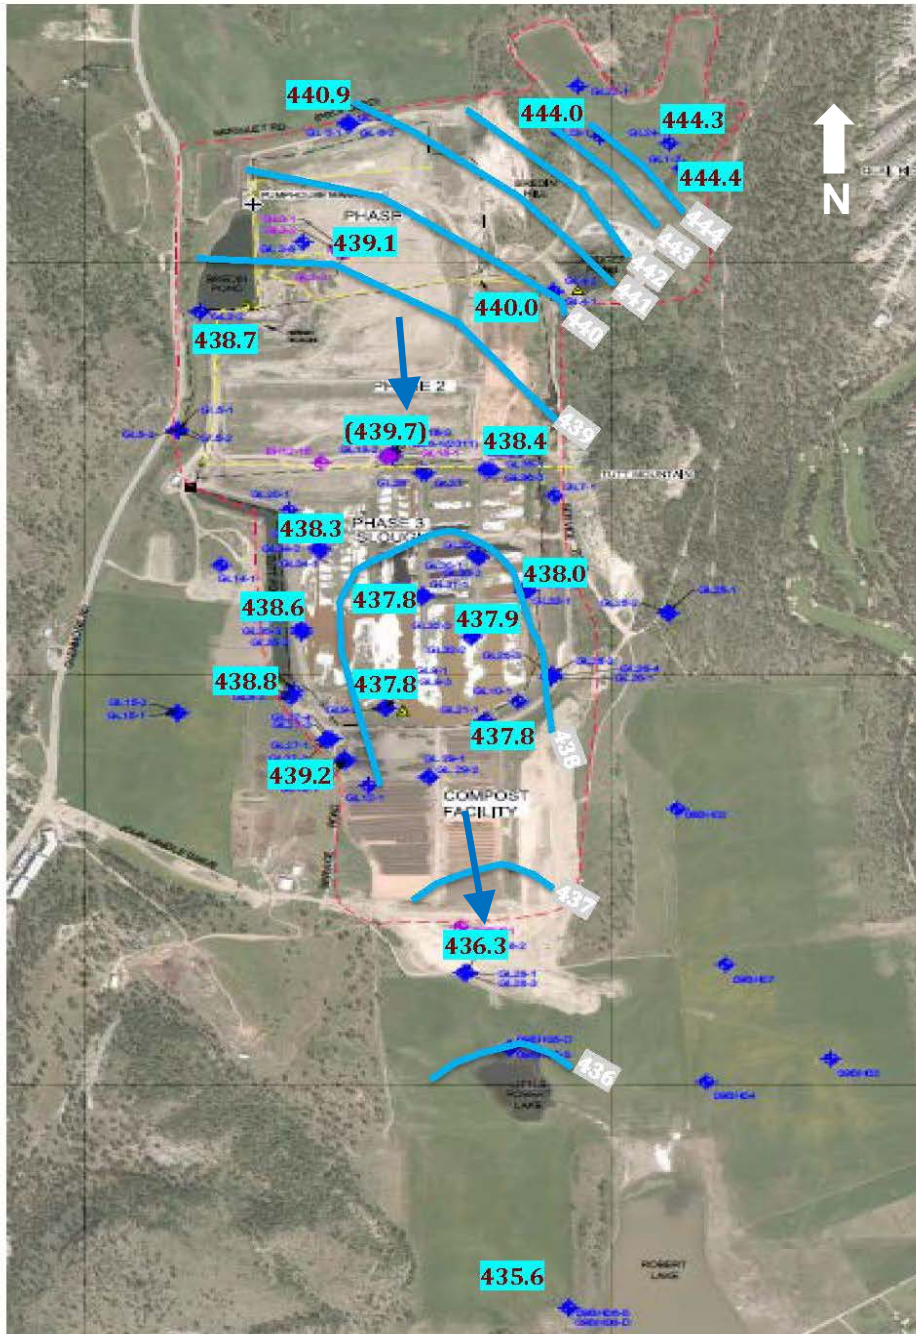
The inferred direction of groundwater flow in the sand and gravel unit at the Landfill is shown on the plan below (blue arrows). Groundwater elevations measured by the City of Kelowna on February 18, 2014. Blue lines represent inferred groundwater contours at 1m intervals.
