SENSITIVE HABITAT INVENTORY AND MAPPING (SHIM)

Mill Creek and Bellevue Creek
Kelowna, British Columbia

Inventory Summary Report

February, 2006

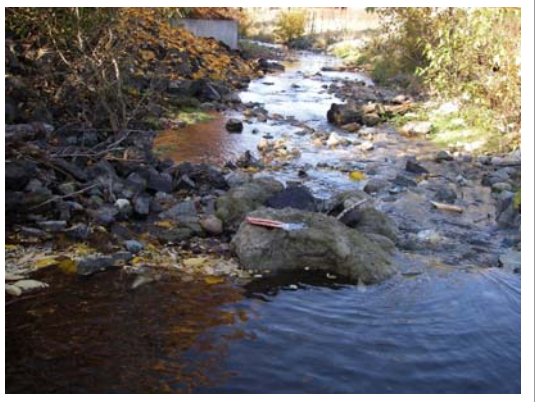
<p>Segment: 2</p> <p>Higher gradient: Above lake level influence; Instream habitat enhancements present. Enhancements adding considerable complexity and responsible for majority of total instream cover.</p>

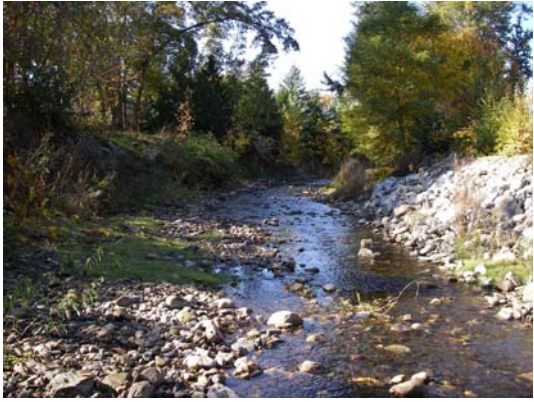
<p>Segment: 3</p> <p>Left bank naturalizing but right bank with recent rip rap armouring. Cobbles and occasional boulders provide minor cover for coarse fish and juvenile salmonids.</p>

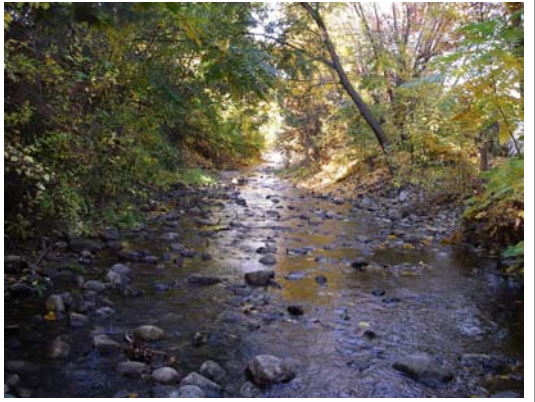
<p>Segment: 4</p> <p>Historic channelization (excavation and diking) but with banks more naturalized. Discontinuous armouring. Occasional veteran cottonwood.</p>

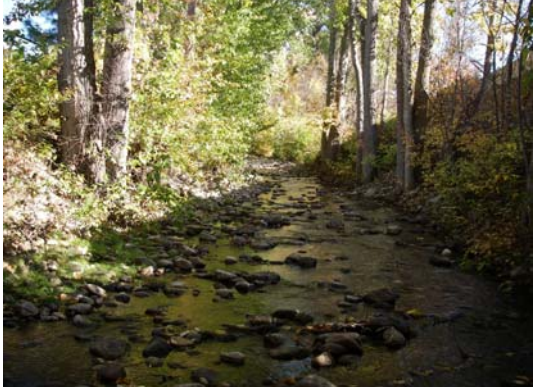
<p>Segment: 5</p> <p>Some naturalization of banks. High imperviousness just beyond left top of bank (parking lot). Both banks composed primarily of cobbles/boulders excavated during channelization. Some veteran cottonwood along bank</p>

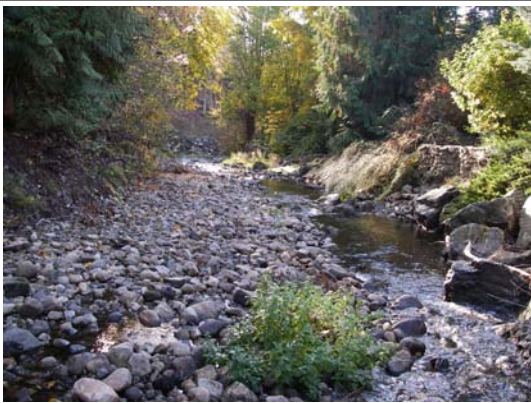
<p>Segment: 6</p> <p>Not channelized but confined by right bank armouring. Boulders and partial functioning enhancements (weirs) providing additional cover. A spring in segment 7 may sustain wetted deep holding pools in enhancements.</p>

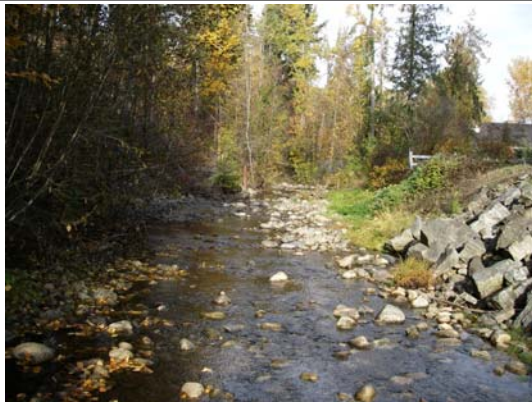
<p>Segment: 7</p> <p>Left bank following natural ravine slope toe. Confined by right bank armouring. Small left bank riparian bench at bottom of segment with cedar-fir-cottonwood veterans.</p>

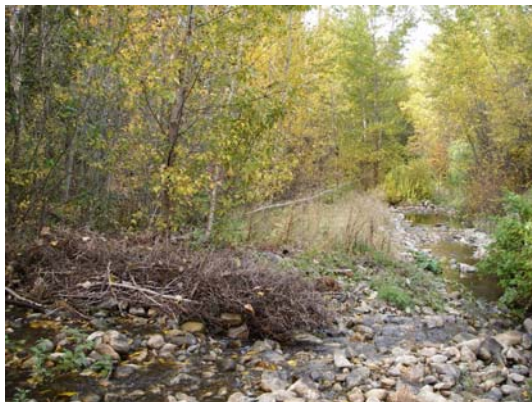
<p>Segment: 9</p> <p>Less confined with side channels, not channelized. Right-bank riparian encroachment. Cottonwood and shrub regeneration on mid channel bars with active side channels.</p>

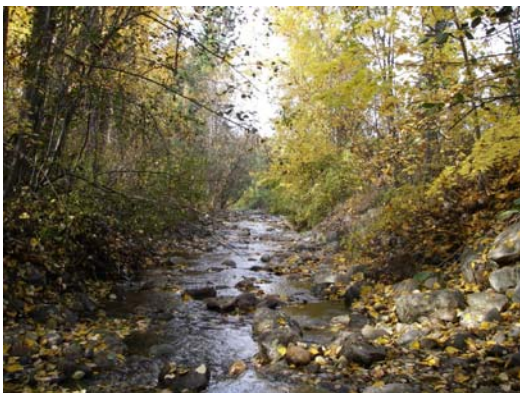
<p>Segment: 10</p> <p>Channelized but naturalizing riparian association. Larger boulders becoming more prevalent improving boulder associated cover.</p>

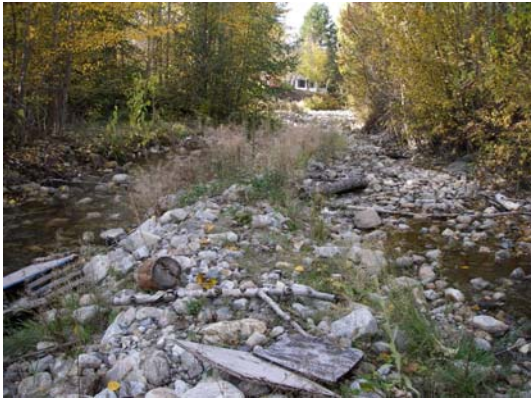
<p>Segment: 12</p> <p>Diking more setback permitting wider channel and allowing development of mid channel bars. A spring occurs on left bank. Therefore deep pool development may provide refuge during low flows.</p>

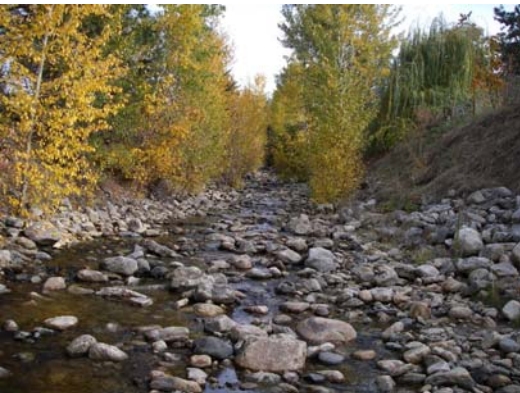
<p>Segment: 13</p> <p>Deep-cut channelization and poor riparian quality. Stream bed instability.</p>

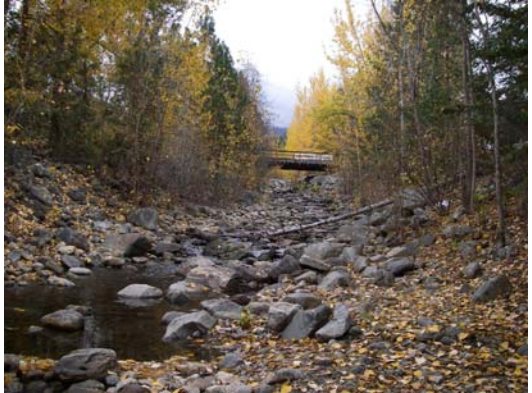
<p>Segment: 14</p> <p>Narrow riparian band naturalizing. Intermittent sections of bank instability from channelization. Boulder-pool complexes providing cover and associated shallow pools and small pockets of suitable spawning substrates.</p>

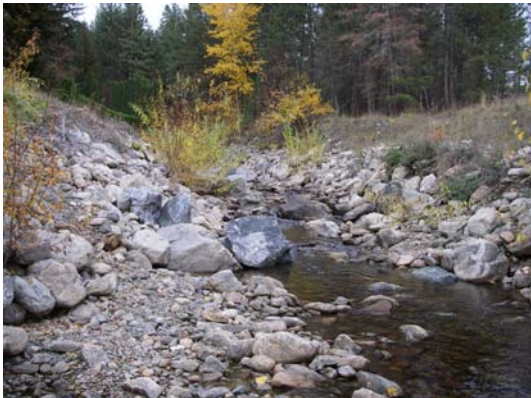
<p>Segment: 15</p> <p>Higher gradient; steep, unstable boulder banks; Recent enhancement works. Right bank nearly devoid of vegetation.</p>

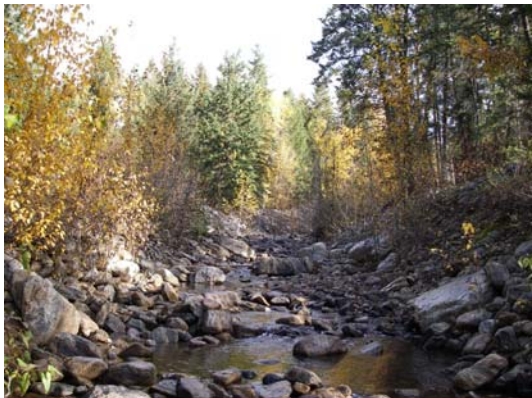
<p>Segment: 16</p> <p>Deep-cut channelization but with some meandering maintained. More stable bank sloping. Despite channelization diking is becoming naturalized with less overall encroachment to top of bank.</p>

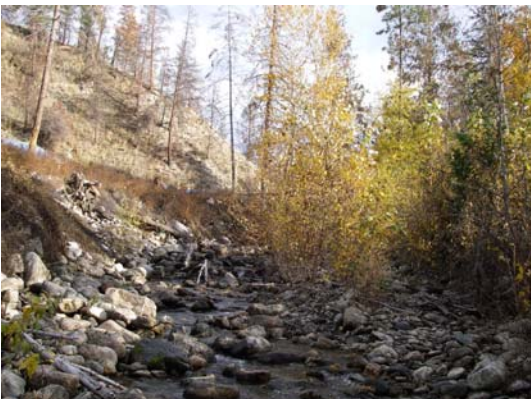
<p>Segment: 17</p> <p>Combined impacts from channelization, agriculture and lack of riparian vegetation, and 2003 forest fire. Siltation occurs over a ~40-m length at the top of the segment, from small tributary and landslide.</p>

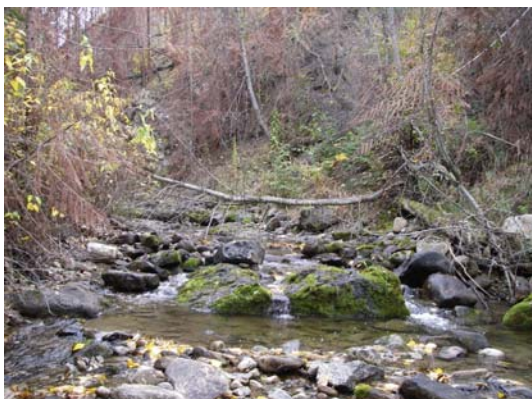
<p>Segment: 18</p> <p>Ravine slope (left bank) small bench below ravine slope (right bank). Boulder cascade with numerous shallow pools. Regular small pockets of gravels among boulders amounting ~4% representing potential spawning habitat for resident rainbow trout (observed).</p>

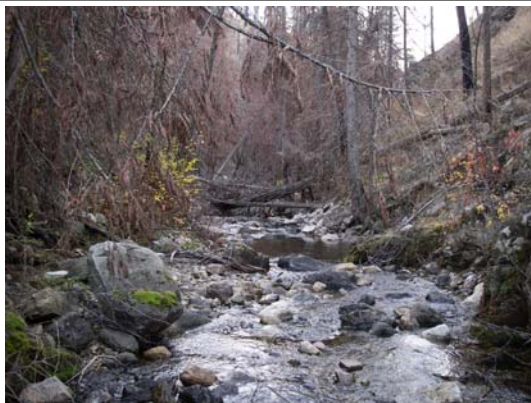
Creek meanders through bedrock ravine. Small alluvial floodplain communities occur on inside bends. Suitable pockets of spawning substrates associated with instream structures (LWD and Boulders). Forest fire disturbance.

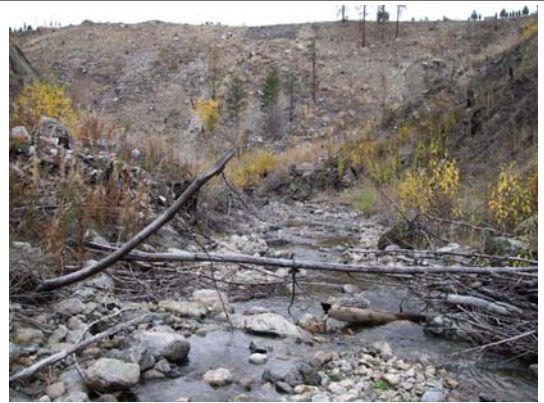
Segment: 20

Modified canyon/ravine by forest fire with subsequent salvage logging. Rainbow trout (juveniles) observed to Crawford Falls.

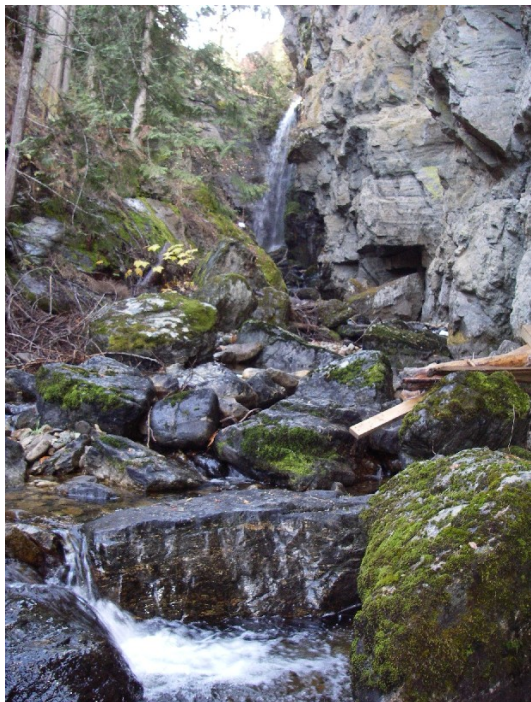
Segment: 21

Steep cascade and waterfall complex through canyon.

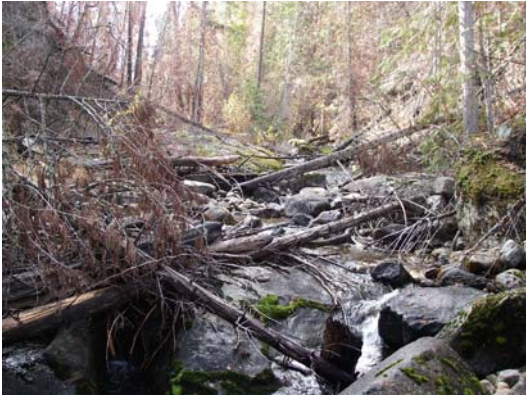
<p>Segment: 22</p> <p>Predominant bedrock substrate over cascade-pool with regular bedrock outcrops within the stream channel.</p>

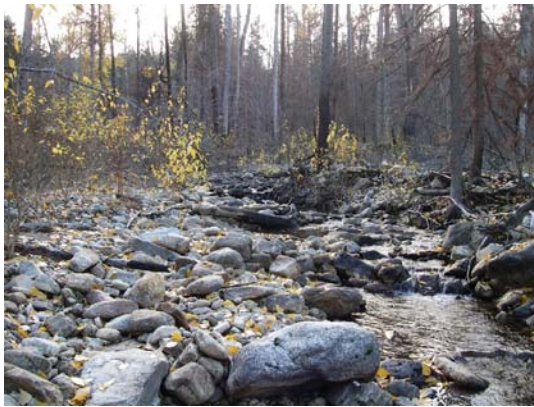
Wide floodplain area flanked by ravine slope and bedrock. No salvage logging has occurred. Mid channel bars/islands; side channels; very dynamic/unstable character over floodplain.

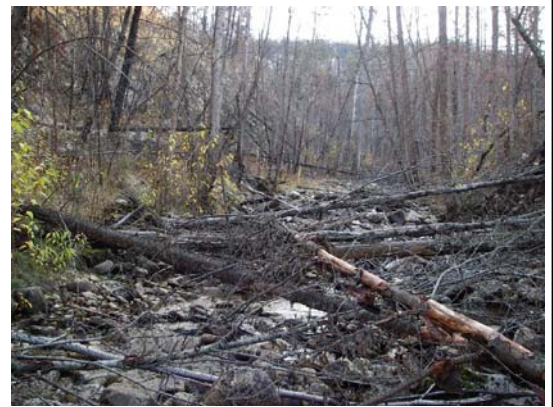
Segment: 25

Some historic channelization to maintain alignment to dam and withdrawal. Occasionally flows adjacent ravine slope toe then meanders to centre of wide floodplain. Entire ravine valley is broad floodplain with predominance of boulders and cobble substrates.

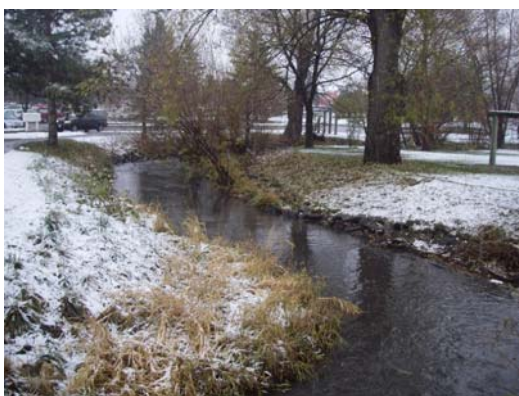
Parkland. Retaining walls and rip rap along majority of segment length on both banks.

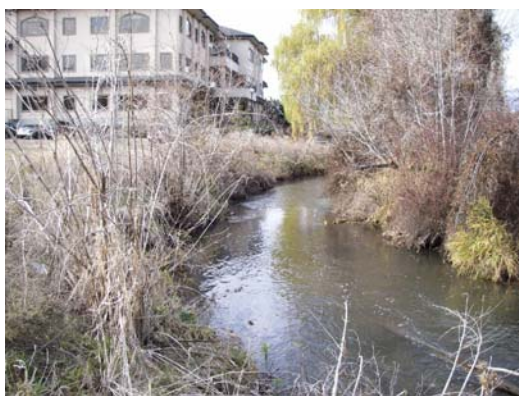
Weak riffle-pool at bottom of segment. Considerable riparian disturbance and bank instability.

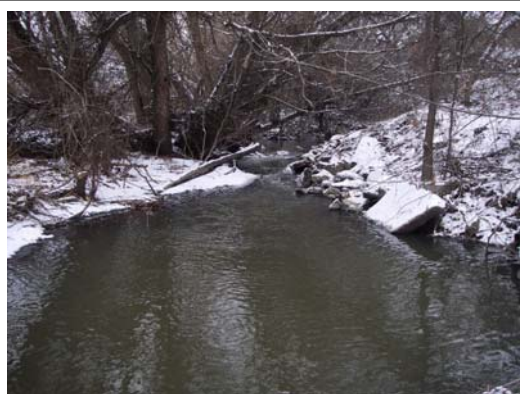
Predominantly slough with occasional run. Industrial on left bank and open, disturbed right bank.

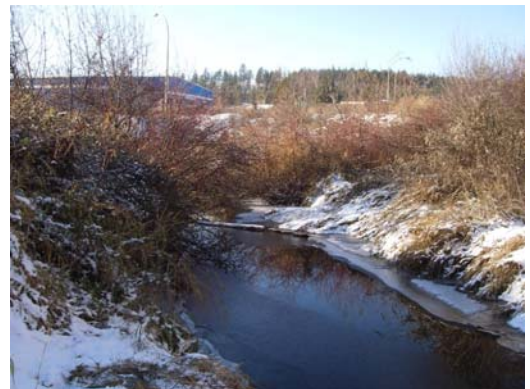
Diking is setback allowing stream channel to meander naturally within. Beaver activity occurs.

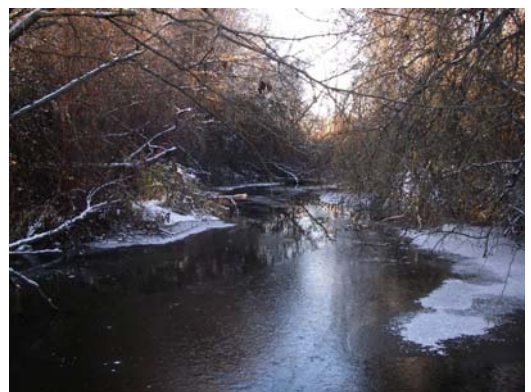
Riparian floodplain/riverine swamp association. Deep slough attributed to beaver activity.
