2022 City of Kelowna Annual Water and Filtration Deferral Report

Prepared for: Interior Health and City of Kelowna

Report Date Covered: January through December 2022

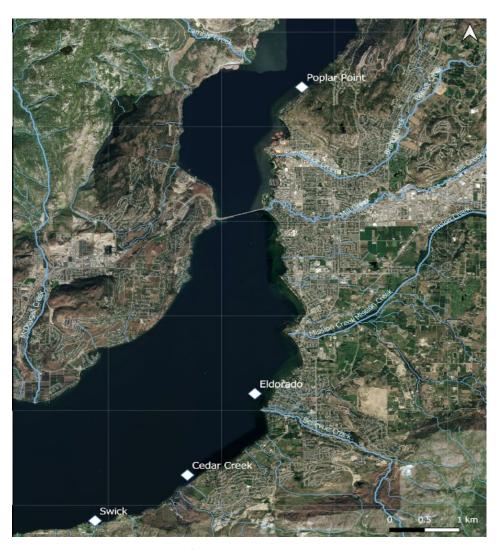
Figure 2. City of Kelowna Water Utility Intake locations

OK Utility is licensed to draw water from Okanagan Lake through 3 primary intakes (Poplar Point, Cedar Creek, and Swick) and 1 seasonal intake (Eldorado) that is typically only utilized during peak water demand periods. Intake locations have been designed and constructed to draw water at designated lake depths to minimize impact of suspended material, microorganisms, and chemical influences. A groundwater well (O'Reilly) is also licenced to supplement drinking water seasonally as irrigation demands increase in Southeast Kelowna.

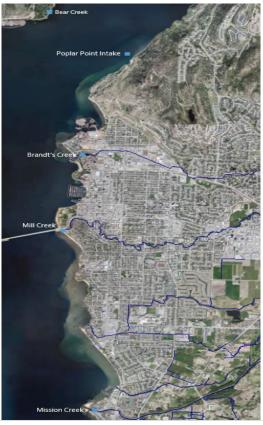
Figure 64. Poplar Point Intake Turbidity relative to surrounding Tributary Turbidities during freshet

Although Brandt's Creek has the closest proximity to the Poplar Point intake, it's relatively low flow and drainage into a designated wetland before entering the lake prevents it from having a significant impact. Mission and Mill creek turbidity seems to coincide with elevated turbidity at the Poplar Point intake (Figure 64, 65). Bear and Brandt's did not appear to have a significant contribution to elevated counts during freshet.

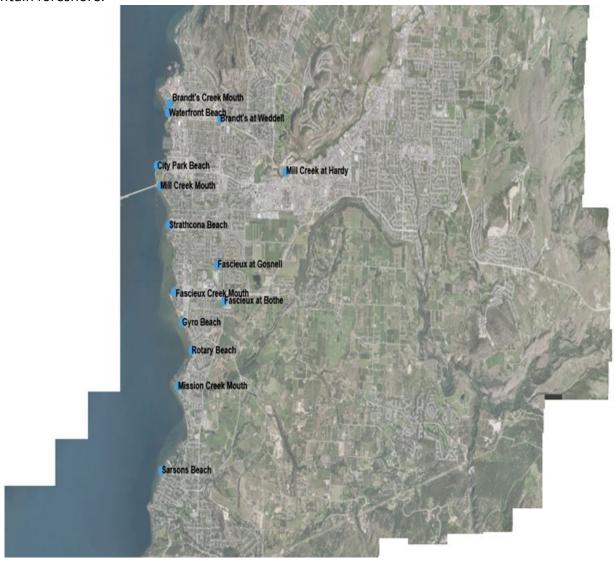
Figure 74. Kelowna Beach and Creek sample sites

The creeks sampled are Brandt's Creek, Mill Creek, Mission Creek, and Fascieux Creek. The main sample site on Brandt's Creek is near the mouth of Brandt's Creek located in Rotary Marsh Wetland on Sunset Drive (Figure 62). The other sample site on Brandt's Creek is a 750mm outfall pipe located on Gordon Drive and Weddell Place which is sampled for first flush as well as during rain events of 7mm or more. The main sample site on Mill Creek is located near the mouth at the end of Lake Avenue (Figure 62). The other sample site on Mill Creek is a 1075mm outfall pipe located on Enterprise Way and Hardy Street which is sampled for first flush as well as during rain events of 5mm or more. The main sample site located on Mission Creek is near the mouth and is accessed by Bluebird Road (Figure 62). Fascieux Creek has three sampling site locations: Gordon Drive between KLO Road and Bothe Road, Gosnell Road and Quesnel Road, and at the end of Watt Road. Beach sites are located between lower Mission and Knox Mountain foreshore.
