SENSITIVE HABITAT INVENTORY AND MAPPING (SHIM)

Mill Creek and Bellevue Creek
Kelowna, British Columbia

Inventory Summary Report

February, 2006

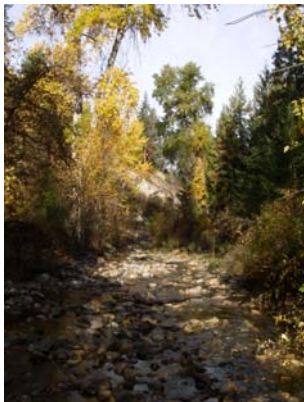
<p>Segment: 8</p> <p>Previously modified channel but naturalized with less encroachment into riparian communities. Cottonwood and shrub regeneration on mid-channel bars with high occasional side channels occurring. Veteran fir, cedar, and cottonwood.</p>

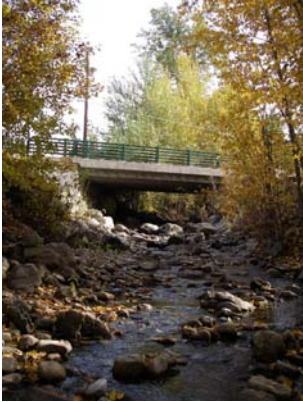
<p>Segment: 11</p> <p>Higher gradient; riffle-cascade; boulders predominant. Sections of high bank instability attributed to over-steepening and removal of riparian vegetation.</p>

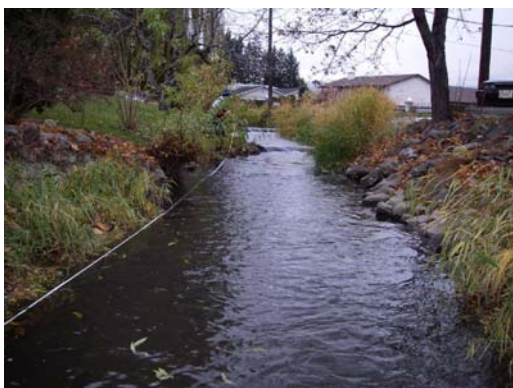
Segment: 10

Discontinuous stonework and retaining walls on both banks. More urbanized than Segment 9.

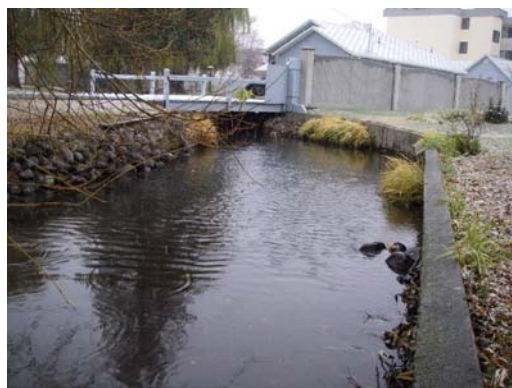
Segment: 11

Retaining walls along both banks with instream enhancements occurring over entire segment length.

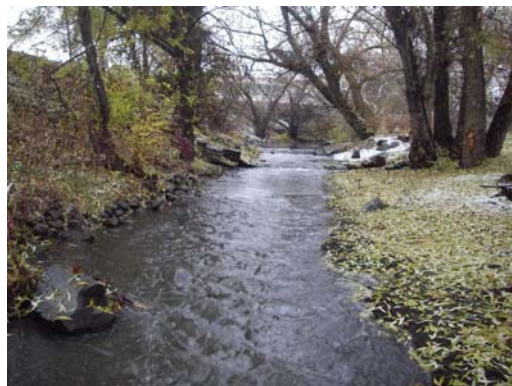
Segment: 13

Instream enhancements adding considerable structural complexity and cover.

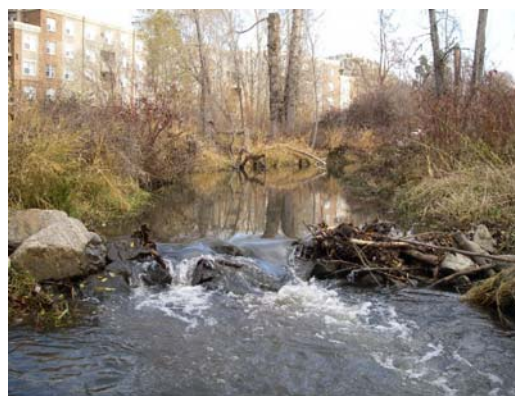
Segment: 15

Deep run-slough hydraulic character influenced by beaver activity.

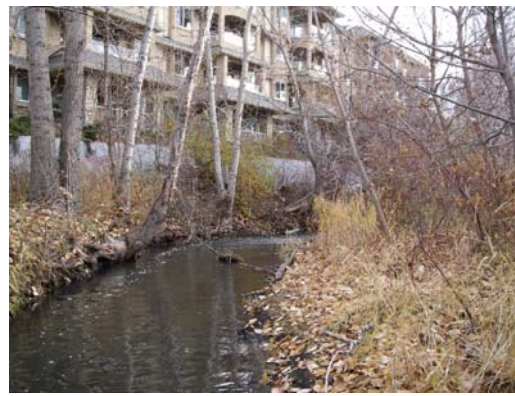
Segment: 17

Riffle-pool-run

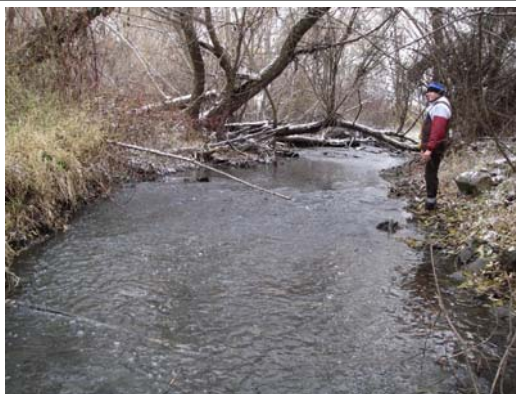
Segment: 28

Riffle-pool-run.

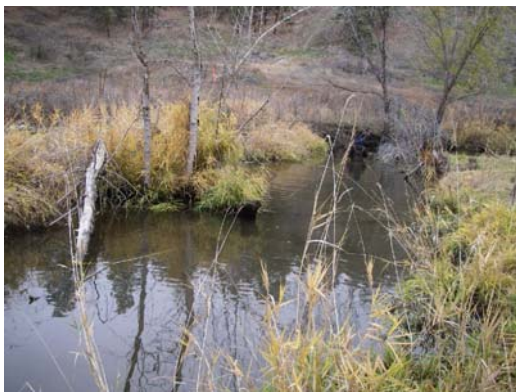
Segment: 30

Evidence of riffle pool morphology prior to beaver activity. This area is now slow moving (slough).

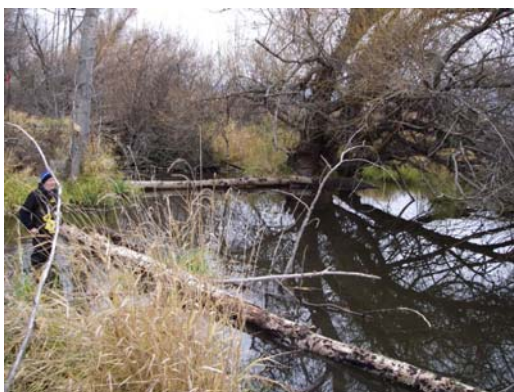
Segment: 31

Riverine slough/wetland complex. High beaver activity/influence.

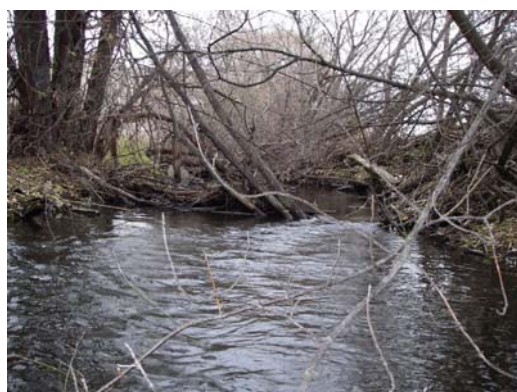
Segment: 32

Confined on left bank by back fill (garbage).

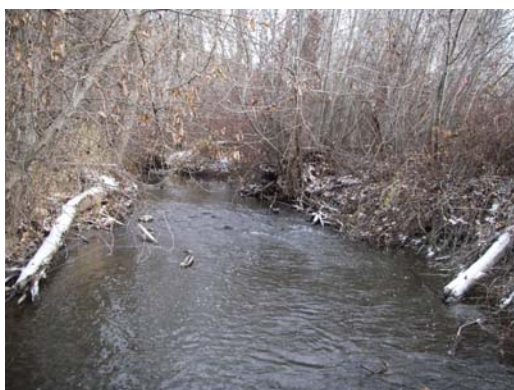
Segment: 35

Intermittent field encroachment to top of bank. Invasive plants.

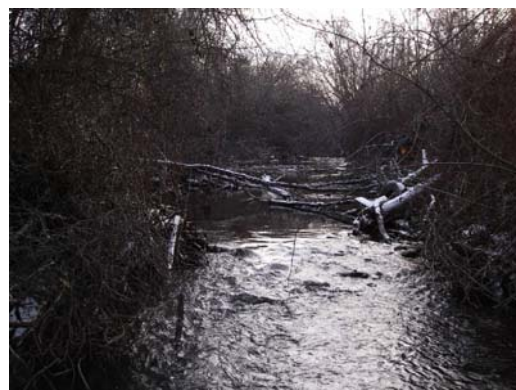
Segment: 36

Lack of treed forest canopy; predominated by tall shrubs (hawthorn).

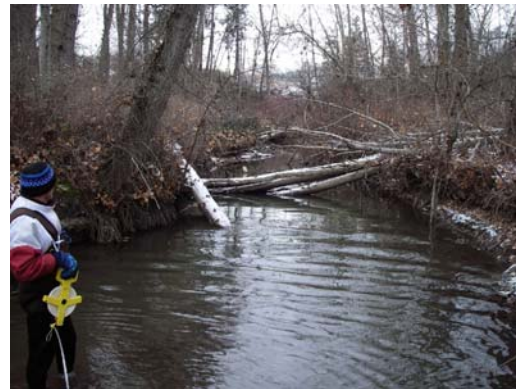
Segment: 40

Tortuous meander through mature cottonwood forest down-cutting in clay substrates.

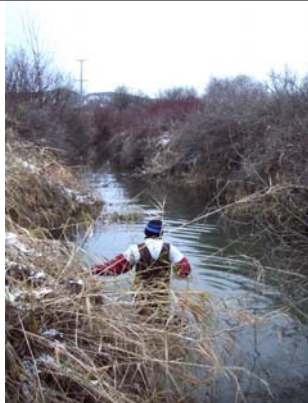
Segment: 41

Channelized during railway development. Creating large impoundment to west of railway.

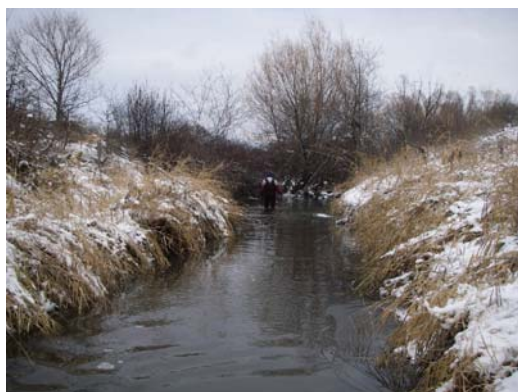
Segment: 43

Channelized by diking. Open grass-herb-low shrub riparian. Low impervious industrial both banks.

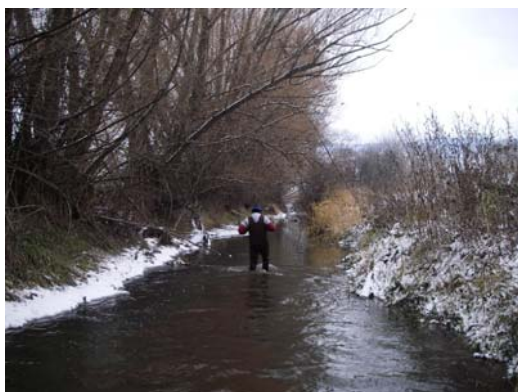
Segment: 44

Channelized through industrial property.

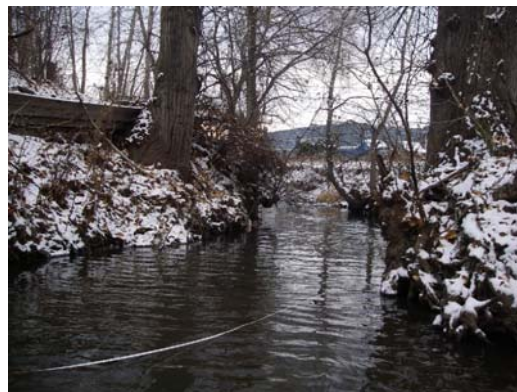
Segment: 45

Natural channel down-cutting through fine silt/clay substrates. Commercial/ industrial encroachment.

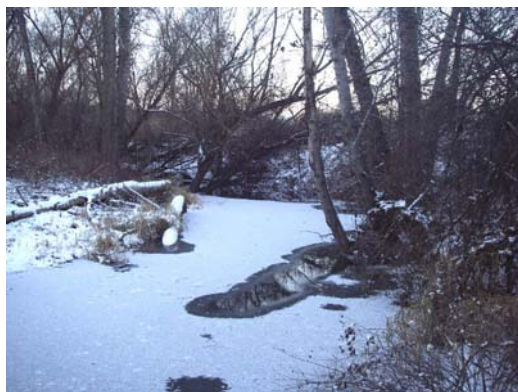
Segment: 46

Very deep beaver ponding. Flood-plain association along right bank and encroachment on left bank.

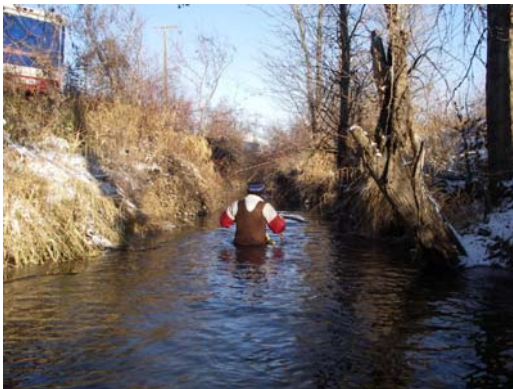
Segment: 48

Channelized/diked both banks. Intermittent armoring on both banks where erosion more prevalent.

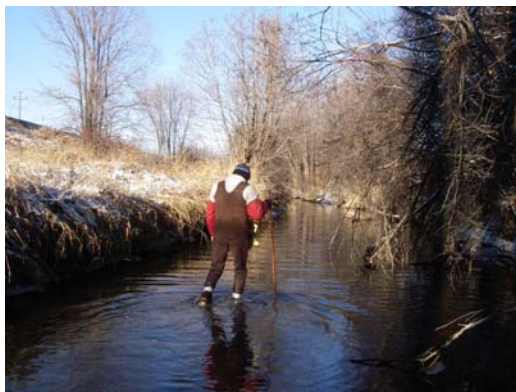
Segment: 50

Channelized by Highway 97 (to west) and to lesser extent by commercial development to east.

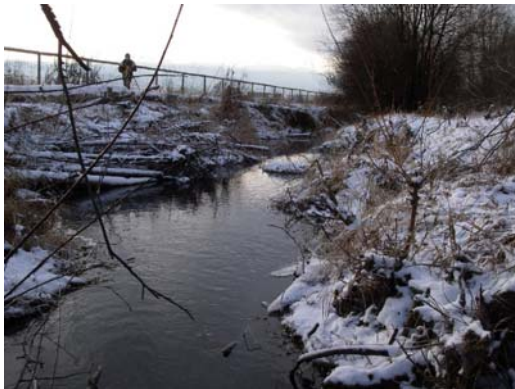
Segment: 52

Ditched through field.
Run with intermittent riffle-pool development.

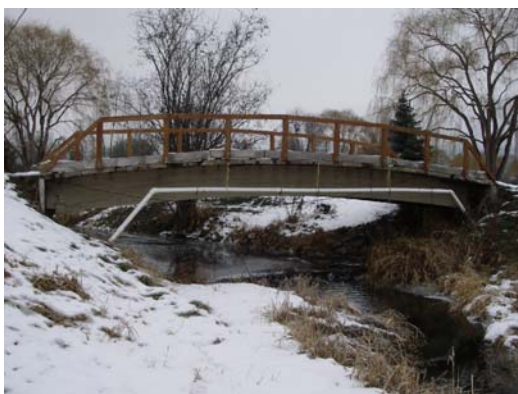
Segment: 57

Slough with portions of riffle-pool-run. Side channels and islands.

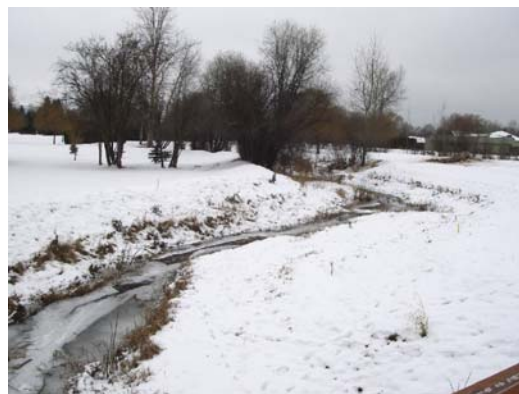
Segment: 58

Riffle-pool-run. Narrower and shallower channel.

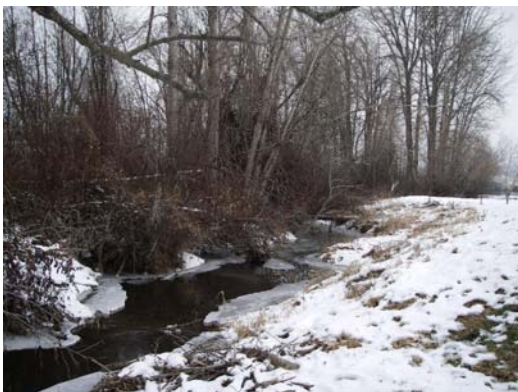
Segment: 59

Riffle-pool-run.

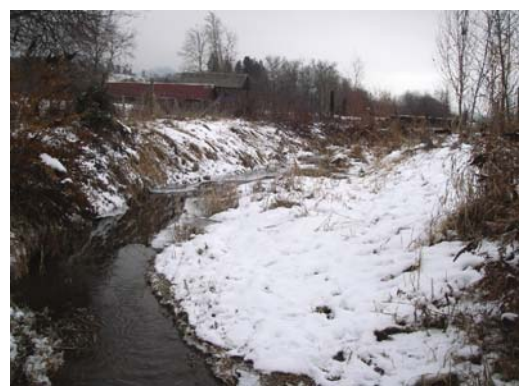
Segment: 60

Riffle-pool-run below bridge, run-slough upstream of bridge. Old bank diking evident.

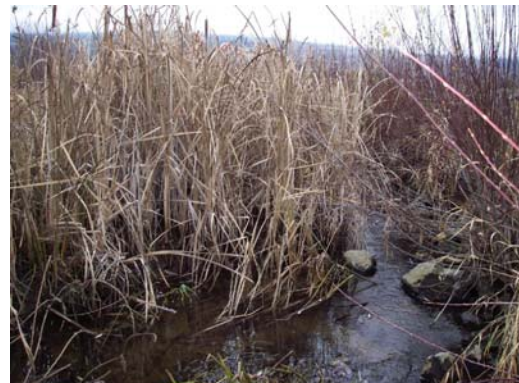
Segment: 62

Ditch less confined and predominated by cattail marsh.

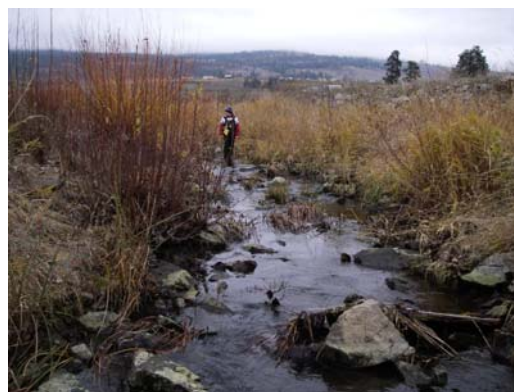
Segment: 64

Bottom of segment armoured with rip rap.

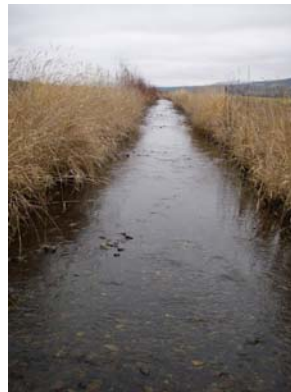
Segment: 66

Weak riffle-pool inhibited by channelization.

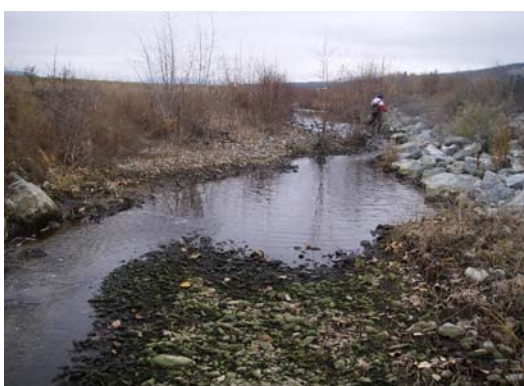
Segment: 67

Wider channel allowing meandering and more prominent riffle-pool character.
